DarkStar[®]

Release Notes v4.0.1

This documentation highlights v4.0.1 release information for the following XKL products:

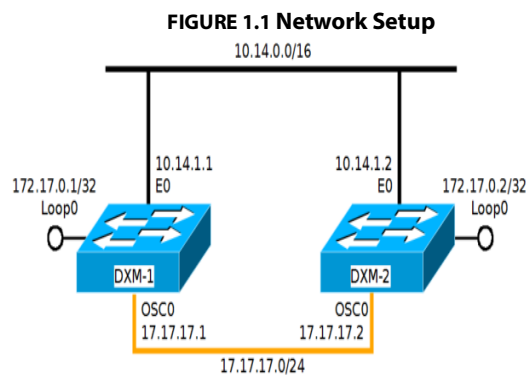
2.4.13 RIP Routing Does Not Advertise Loopback Routes Under Some Conditions

Refer to [Figure 1.1](#), which illustrates the network setup addressed by this release note. The diagram is provided for example only.

- **if** two DarkStar systems (e.g., DXM-1 and DXM-2) are connected via copper Ethernet links (e.g., E0 on DXM-1 and E0 on DXM-2) to the same network (e.g., 10.14.0.0/16) and directly connected via an OSC Ethernet link (e.g., OSC0 on DXM-1 to OSC0 on DXM-2), creating a network loop, **and**
- **if** Routing Information Protocol (RIP) is enabled on the copper Ethernet links and on the OSC link in both systems, **and**
- **if** one of the copper Ethernet links is disabled (e.g., E0 on DXM-1), either physically or administratively, **then**

the system with the disabled copper Ethernet link (DXM-1) will switch RIP route advertisements from the copper Ethernet link (E0, 10.14.1.1) to the OSC link (OSC0, 17.17.17.1), but RIP will not advertise loopback routes (e.g., 172.17.0.1/32) via the OSC to the remote system (DXM-2). Connection attempts to those destinations from the remote system (DXM-2) will be unsuccessful.

To recover from this condition, perform a `clear rip` command on the system with the disabled copper Ethernet link (DXM-1) to re-trigger route advertisements. **Note:** This condition does not occur if the OSC link is disabled and RIP route advertisements are switched from the OSC link to the copper Ethernet link.
